Road Safety Audit Public Report

I-80 Mercer County – Mile Markers 0 to 15

Submitted November 2020 to: PennDOT District 1-0

Prepared by: Michael Baker International

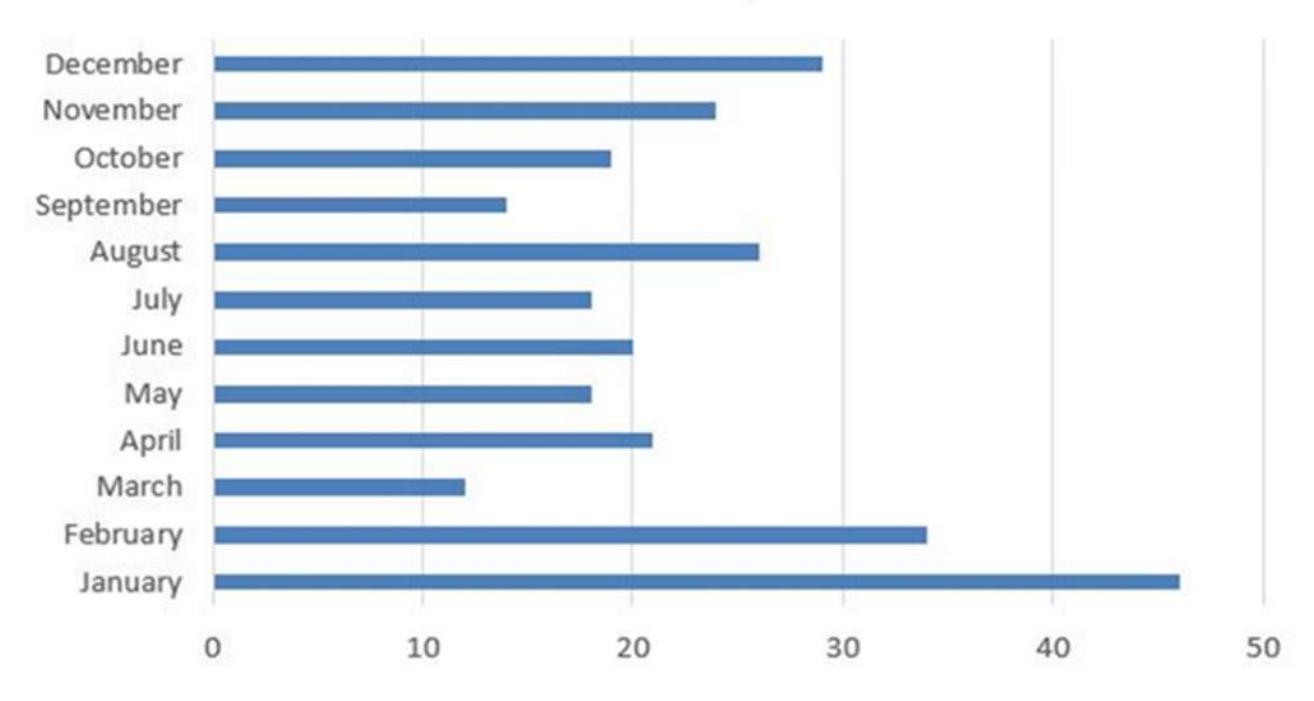
Figure 4

Two other crash trends that stand out in this corridor lay within the time of day crashes occur and time of year crashes occur. Typically, crash numbers rise and fall with the peaks and off-peaks of vehicular volumes. In this corridor, more crashes occur at off-peak times such as nighttime hours and winter months as displayed in **Figure 3** and **Figure 4**.

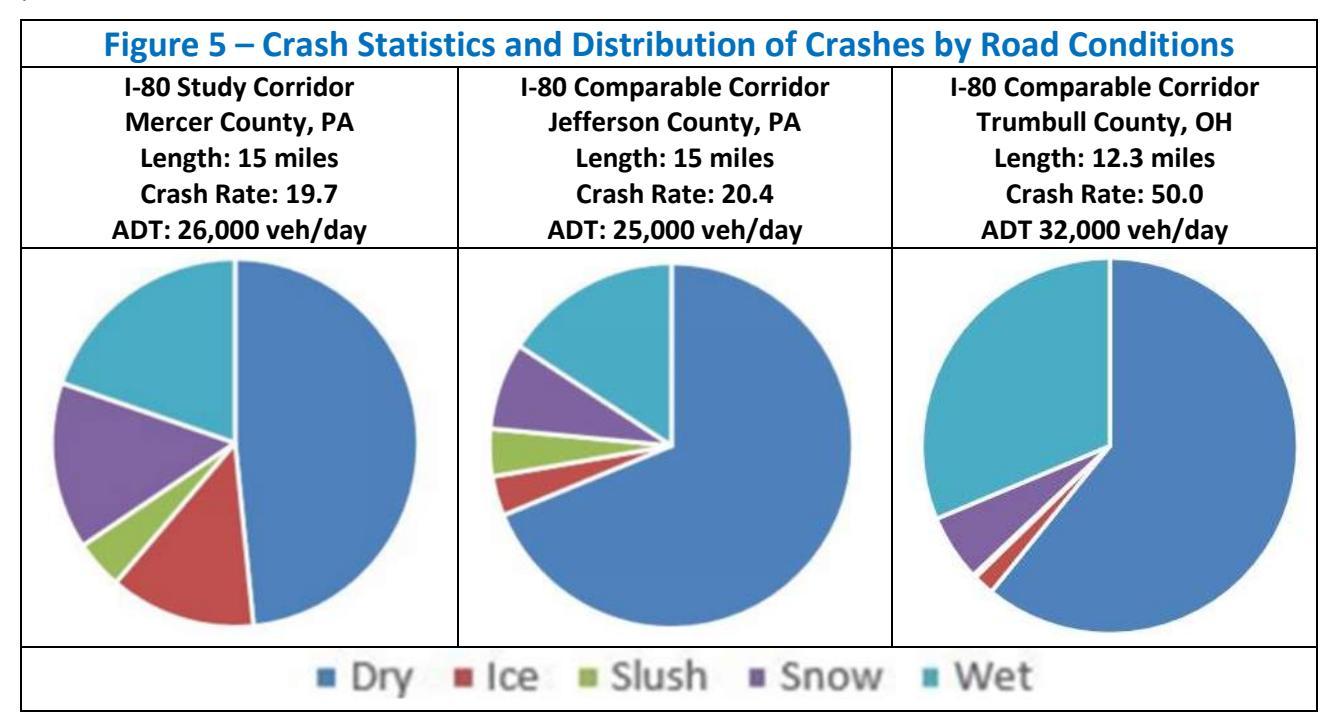
The crash statistics of the study corridor were compared with crash statistics along similar I-80 segments on either side of the study corridor in Trumbull County, Ohio and Jefferson County, Pennsylvania. The statistics were reviewed over the same five-year period to capture similar weather conditions. These crash statistics allow for a comparison of crash rates among the corridors. The findings are summarized in **Figure 5**.

The corridor of I-80 in Trumbull County, Ohio was selected as a comparable corridor due to it being adjacent to the study corridor. This corridor's average daily traffic (ADT) of 32,000 vehicles per day (veh/day) and is similar to the study corridor having an ADT of 26,000 veh/day. The crash rate of 50.0 crashes per million vehicle miles travels on this this corridor is higher compared to the study corridor crash rate of 19.7 crashes per million vehicle miles. This difference can be contributed to Ohio including non-reportable crashes in their data for crash totals whereas Pennsylvania does not include non-reportable crashes in their data for crash totals. However, the crashes occurring on dry pavement conditions is more in line with expected trends near 70% as compared to that with the study corridor having dry condition crashes just below 50%.

The corridor of I-80 in Jefferson County, Pennsylvania was selected as the other comparable corridor due to it having similar horizontal geometries and profile grades. This corridor's average daily traffic (ADT) of 25,000 vehicles per day (veh/day) is similar to that of the study corridor. The crash rate of 20.4 crashes per million vehicle miles is also close to the study corridor. The crash data from Jefferson County, Pennsylvania also matches the expected trend with approximately 70% of crashes occurring on dry pavement.

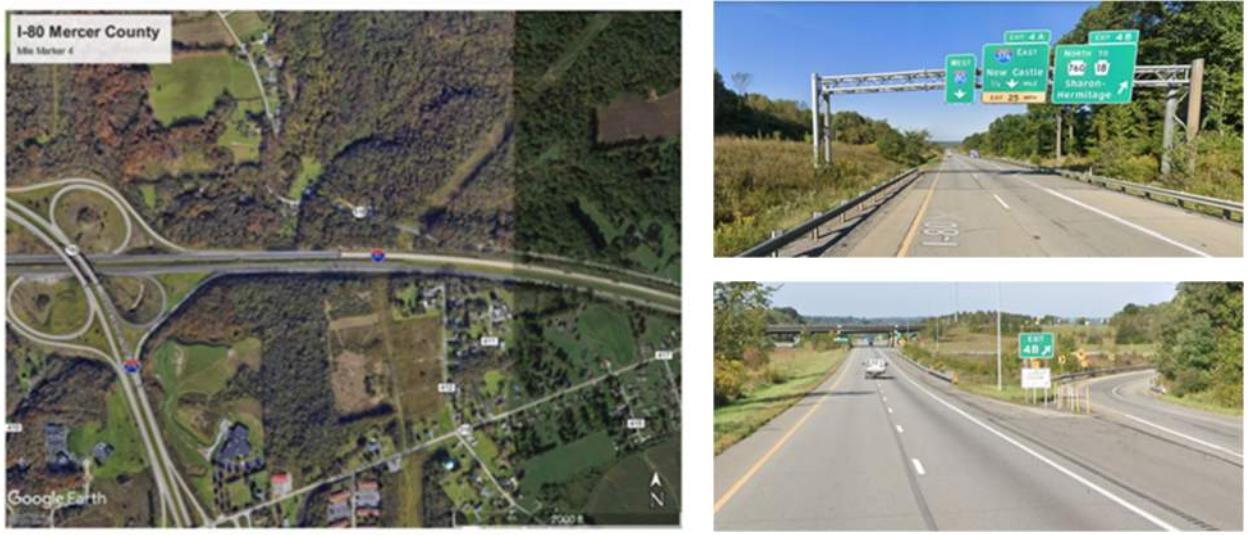
I-80 Westbound – Segment 41 Near MM 4

This location travels at a downhill grade of approximately 4%. The pavement surface consists of concrete pavement along the horizontal curve followed by asphalt pavement throughout the interchange. The concrete pavement at this location has skid test results below target value. The deceleration lane for the exit ramp is longer than required and leads to a tight horizontal curve. The deceleration lane length with the downhill grade may contribute to higher speeds. The common type of crash in this location is run- off-the-road type crash due to inclement weather and/or excessive speed. Additionally, this segment was the location of the crash involving extended I-80 shutdown November 12, 2019 (Tuesday @ 3:15 pm).

lssue	Mitigation Opportunity	Level of Effort	Potential Safety Benefit
Concrete pavement skid test results below target value.	Apply high friction surface treatment (HFST).	Low	High
Location includes run off the road crashes.	Apply new pavement surface.	High	High
Possible deceleration lane too long leading to excessive speeds.	Shorten deceleration lane via pavement markings.	Low	Low
	Shorten deceleration lane via full depth reconstruction.	High	Low
	Change ground mount advisory speed sign (30 mph) 600' advance of curve to overhead advisory speed sign (25 mph) with W1-13R Truck Rollover Right Curve Sign.	Medium	Medium

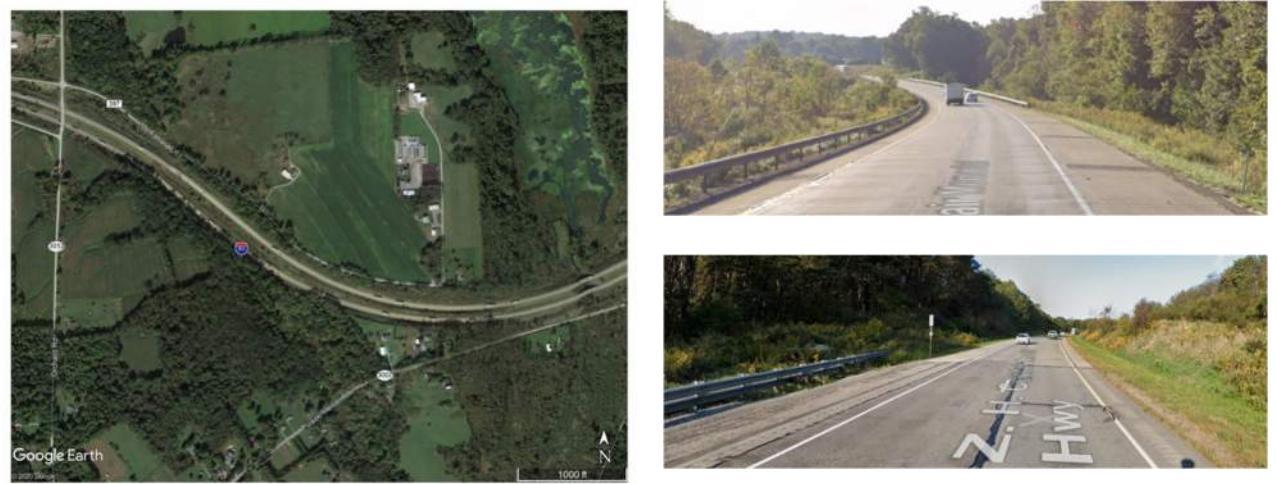
I-80 Eastbound, Segment 104 Near MM 11

This location travels at a downhill grade of approximately 4%. The pavement surface consists of concrete pavement having skid test results below target value. The horizontal curve has a radius of 3274 feet with a superelevation of 4.6% (from I-80 as-built plans **Appendix G REDACTED**). This is less than the design standard of 5.8% for the radius at 70 MPH. The common type of crash in this location is the run-off-the-road type crash due to inclement weather and/or excessive speed. There was one fatal crash in wet conditions due to a driver traveling the wrong direction along the interstate.

Issue	Mitigation Opportunity	Level of Effort	Potential Safety Benefit
Concrete pavement skid test results below target value.	Apply high friction surface treatment (HFST).	Low	High
Horizontal curve superelevation does	Add oversized chevron signs.	Low	Low
speed limit.	Add advisory speed plaques.	Low	Low
	Apply new pavement surface.	High	High
	Increase horizontal curve superelevation.	High	High

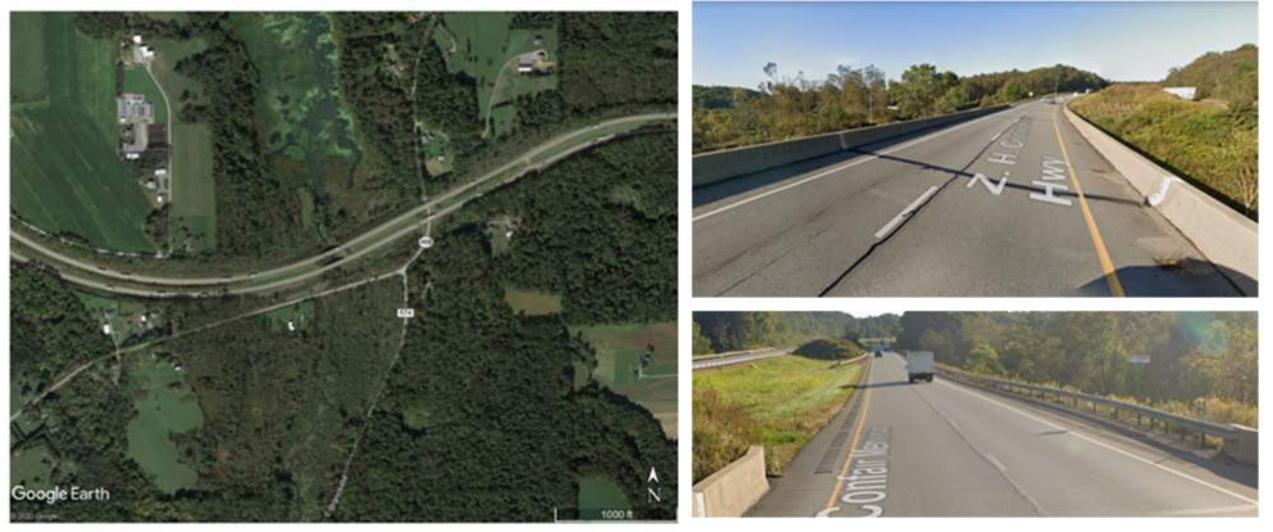
I-80 Eastbound, Segment 110 Near MM 11.5

This location travels at an uphill grade of approximately 3%. The pavement surface consists of asphalt pavement having skid test results at or above target value. The horizontal curve has a radius of 3274 feet with a superelevation of 4.6% (from I-80 as-built plans **Appendix G REDACTED**). This is less than the design standard of 5.8% for the radius at 70 MPH. The common type of crash in this location is the run-off-the-road type crash due to inclement weather and/or excessive speed.

Issue	Mitigation Opportunity	Level of Effort	Potential Safety Benefit
Shoulder narrows over bridge with evidence of vehicles rubbing barrier and adjacent guide rail.	Increase shoulder width over bridge.	High	High
Horizontal curve superelevation does not meet design criteria for posted speed limit.	Apply high friction surface treatment (HFST).	Low	High
	Add large chevron signs.	Low	Low
	Add speed advisory plaques.	Low	Low
	New pavement surface with increased superelevation.	High	High

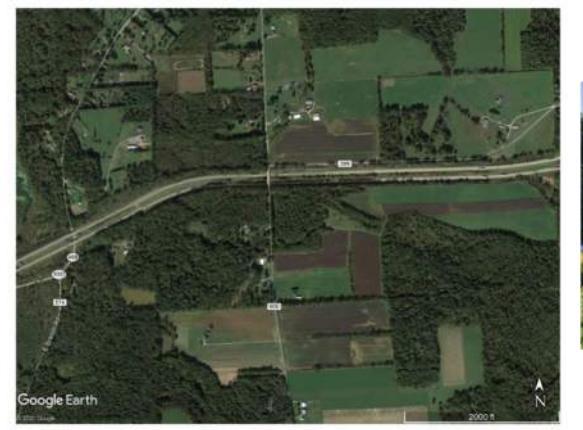
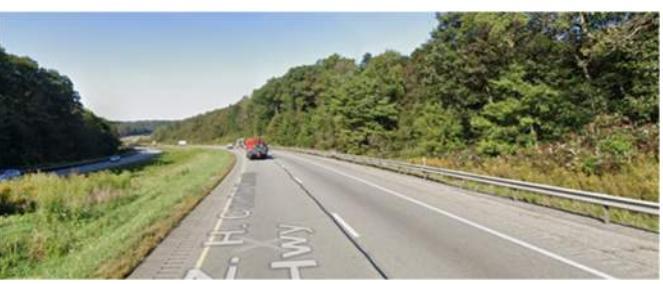
I-80 Westbound, Segment 111 Near MM 11.5

This location travels at a downhill grade of approximately 3.8%. The pavement surface consists of asphalt pavement having skid test results at or above target value. The horizontal curve has a radius of 2090 feet with a superelevation of 3.8% (from I-80 as-built plans **Appendix G REDACTED**). This is less than the design standard of 7.8% for the radius at 70 MPH. The common type of crash in this location is the run-off-the-road type crash due to inclement weather and/or excessive speed.

lssue	Mitigation Opportunity	Level of Effort	Potential Safety Benefit
Horizontal curve superelevation does not meet design criteria for posted speed limit.	Apply high friction surface treatment (HFST).	Low	High
	Add large chevron signs.	Low	Low
	Add speed advisory plaques.	Low	Low
	New pavement surface with increased superelevation.	High	High

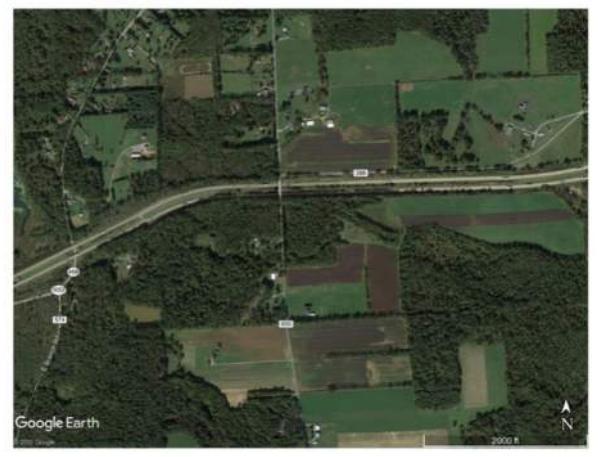
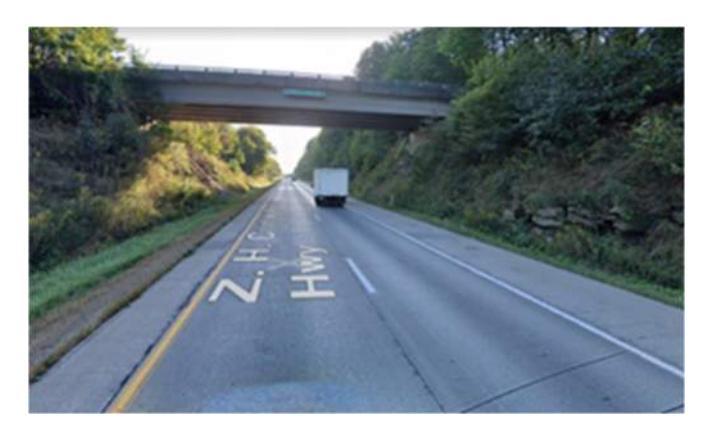
I-80 Eastbound, Segment 114 Near MM 12

This location also known as the "Rock Area" travels at an uphill grade of approximately 3.4%. The pavement surface consists of concrete pavement having skid test results below target value. The horizontal curve has a radius of 1910 feet with a superelevation of 7.8% (from I-80 as-built plans **Appendix G REDACTED**). This is less than the design standard of 8% for the radius at 70 MPH. Delineation is also missing along the outside of the horizontal curve. This location has refreeze issues due to the shade provided by the rock cut, bridge overhead and vegetation. The common type of crash in this location is the run-off-the-road type crash due to inclement weather and/or excessive speed. Secondary crashes are also an occurrence at this location.

lssue	Mitigation Opportunity	Level of Effort	Potential Safety Benefit
Concrete pavement skid test results below target value.	Apply high friction surface treatment (HFST).	Low	High
Horizontal curve superelevation does	Add large chevron signs.	Low	Low
speed limit.	Add speed advisory plaques.	Low	Low
	New pavement surface with increased superelevation.	High	High
No delineation on outside curve within median.	Add delineation to outside curve within median.	Low	Medium
Refreeze issues due to shade and high wind.	Pave unofficial turnaround prior to horizontal curve for maintenance vehicles.	Medium	Medium
	Trim/cut down trees within right- of-way.	Medium	Low
	Add ITS pavement sensors to better inform maintenance crews when pavement requires de-icing treatment.	Medium	Medium

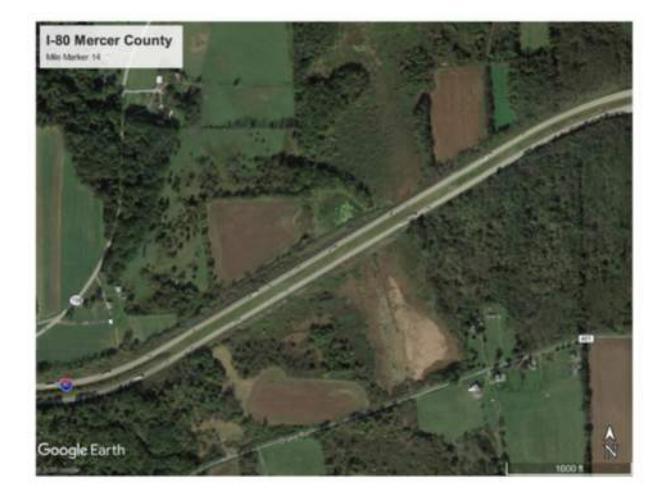
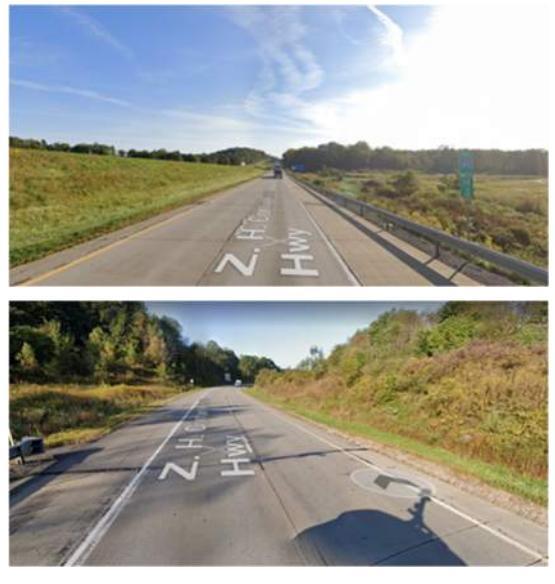
I-80 Eastbound, Segment 130 Near MM 13.5

This location has a pavement surface consisting of asphalt within horizontal curve. The pavement surface changes to concrete coming out of horizontal curve into the tangent section. The concrete pavement surface consists of skid test results below target value. The horizontal curve has a radius of 1910 feet with a superelevation of 7.8% (from I-80 as-built plans **Appendix G REDACTED**). This is less than the design standard of 8% for the radius at 70 MPH. The common type of crash in this location is the run-off-the-road type crash due to inclement weather and/or excessive speed. The change in pavement surface friction coming out of the curve is unexpected by drivers and is a contributing factor to the crash cluster. The raised brush covered slope in the median also prevents drivers from seeing the crashes outside of the horizontal curve creating a hazard for drivers and emergency responders. Secondary crashes are also an occurrence at this location. Additionally, this segment was the location of the crash involving a double fatal February 10, 2019 (Sunday @ 6:30 pm)

Issue	Mitigation Opportunity	Level of Effort	Potential Safety Benefit
Concrete pavement skid test results below target value.	Apply high friction surface treatment (HFST).	Low	High
Horizontal curve superelevation does	Add large chevron signs.	Low	Low
speed limit.	Add speed advisory plaques.	Low	Low
	New pavement surface with increased superelevation.	High	High
Reduced line of sight from withing	Clear brush in median.	Medium	High
horizontal curve.	Consider regrading median with further investigation.	High	High

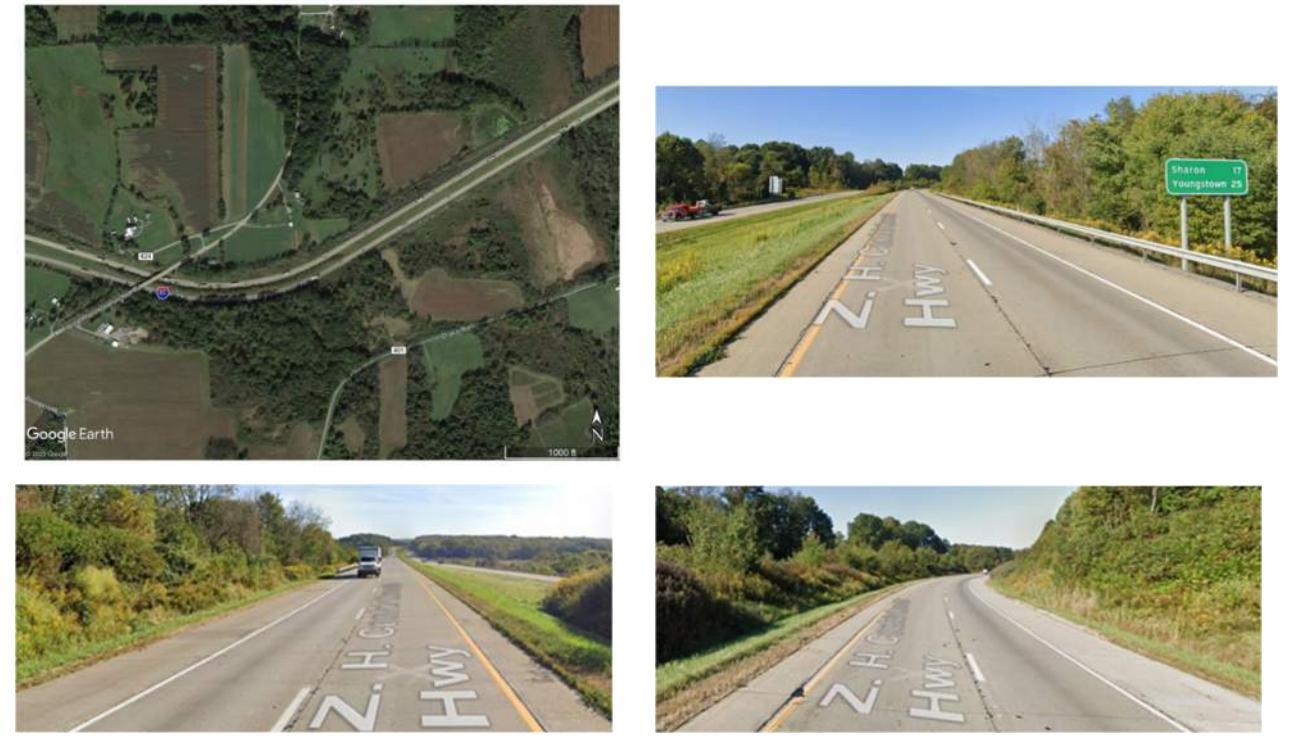
I-80 Westbound, Segment 135 Near MM 13.5

This location has a pavement surface consisting of concrete pavement having skid test results below target value. The horizontal curve has a radius of 1910 feet with a superelevation of 7.8% (from I-80 as-built plans **Appendix G REDACTED**). This is less than the design standard of 8% for the radius at 70 MPH. Delineation is also missing along the outside of the horizontal curve. The common type of crash in this location is the run-off-the-road type crash due to inclement weather and/or excessive speed. One crash was caused by sun glare in this location.

lssue	Apply high friction surface treatment (HFST).	Level of Effort	Potential Safety Benefit
Concrete pavement skid test results below target value.	Apply high friction surface treatment (HFST).	Low	High
Horizontal curve superelevation does	Add large chevron signs.	Low	Low
speed limit.	Add speed advisory plaques.	Low	Low
	New pavement surface with increased superelevation.	High	High
No delineation on outside curve within median.	Add delineation to outside curve within median.	Low	Medium

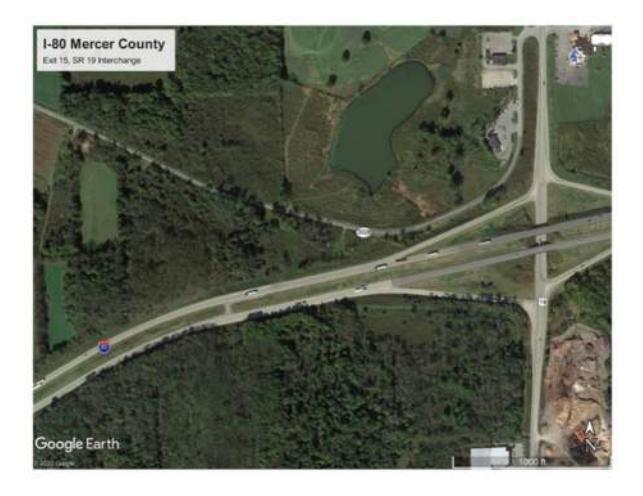
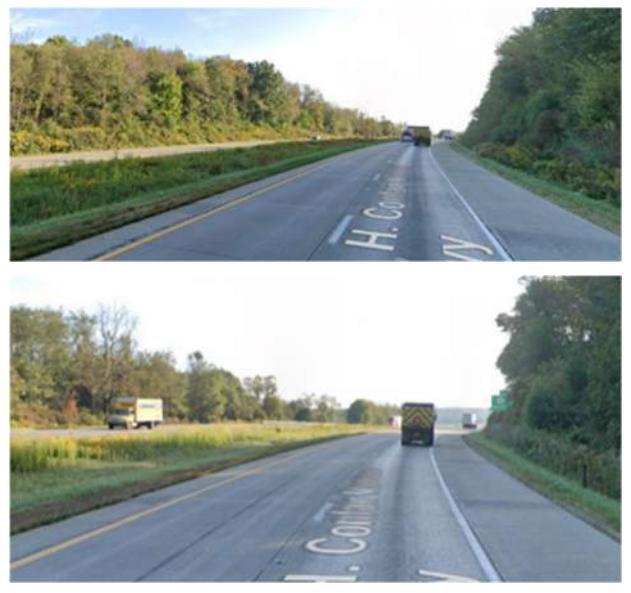
I-80 Eastbound, Segment 140 Near MM 14

This location has a pavement surface consisting of concrete pavement having skid test results below target value. The horizontal curve has a radius of 3125 feet with a superelevation of 5.2% (from I-80 as-built plans **Appendix G REDACTED**). This is less than the design standard of 6% for the radius at 70 MPH. Delineation is also missing along the outside of the horizontal curve. The exit 15 sign and deceleration lane are hidden around crest vertical curve and within brush on inside horizontal curve. Additionally, the exit ramp deceleration lane appears to be part of horizontal curve. The common type of crash in this location is the run-off-the-road type crash due to inclement weather and/or excessive speed.

lssue	Mitigation Opportunity	Level of Effort	Potential Safety Benefit
Concrete pavement skid test results below target value.	Apply high friction surface treatment (HFST).	Low	High
Horizontal curve superelevation does	Add large chevron signs.	Low	Low
speed limit.	Add speed advisory plaques.	Low	Low
	New pavement surface with increased superelevation.	High	High
No delineation on outside curve within median.	Add delineation to outside curve within median.	Low	Medium
Exit 15 sign and deceleration lane hidden around crest vertical curve and within brush on inside horizontal curve. Exit ramp deceleration lane appears to be part of horizontal curve.	Clear brush along inside horizontal curve.	Medium	High
	Extend dotted extension line on exit ramp to guide vehicles of separation between travel lane and deceleration lane.	Low	Medium
	Add ½ mile exit guide sign.	Medium	Medium

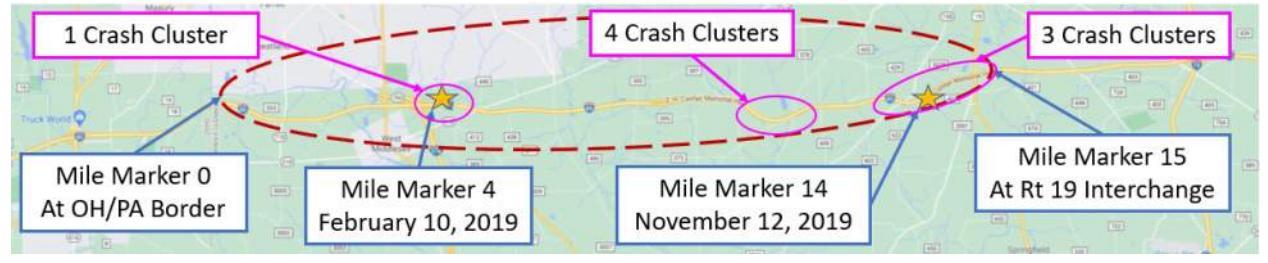
Figure 6 – Overall Study Corridor Crash Clusters and Noteworthy Crashes

The I-80 study corridor is characterized by a freeway that has many horizontal curves and changes in vertical grades. The pavement surface varies among segments between asphalt and concrete. The subsurface of the asphalt pavement structure is deteriorating. The surface of the concrete pavement has locations with skid test results below the target value. The horizontal curves throughout the corridor has superelevation that does not meet the value required for the posted speed of 70 mph. The speed limit changed from 65 mph to 70 mph in May 2016. The existing superelevation has been identified from the I-80 As-built Plans in **Appendix G REDACTED** and will need to be field verified. As a result, the District is looking to generate three (3) repaving/rehabilitation projects spanning roughly 5-mile sections within the 15-mile study corridor. The I-80 section of Mile Marker 0 through Mile Marker 5 is currently in design. Short term mitigation opportunities might be ideal in high crash locations if the Let dates occur in the distant future.

Additionally, the study corridor is notorious for sudden inclement weather that sees snow squalls and refreeze areas. Snow, rain, sleet and ice make up more than half of the contributing factors to crashes. Most of the crash clusters occurred in the eastern side of the study corridor as circled in **Figure 6** above. Two noteworthy crashes occurred during inclement weather in 2019, one resulting in a double fatal and the other resulting in an extended interstate shutdown as shown in the stars in **Figure 6**.

Issue	Mitigation Opportunity	Level of Effort	Potential Safety Benefit
Horizontal curve superelevation does not meet criteria for posted speed limit. Speed limit changed from 65 mph to 70 mph May 2016.	Flattening horizontal curves or improving superelevation is considered the ultimate solution for reducing crashes in a horizontal curve. The superelevation can be increased within the existing roadway geometries to meet the posted speed limit design criteria.	High	High
Pavement surface changes between asphalt and concrete.	Apply high friction surface treatment (HFST).	Low	High
Concrete pavement skid test results below target value.	Apply new pavement surface.	High	High
Median delineation missing in large sections throughout the corridor.	Incorporate Median Delineation through the horizontal curves in the study corridor.	Low	High
Guide rail delineation missing in some locations.	Replace missing guiderail delineators.	Low	Medium

Mile marker signage currently posted on the mile location.	Incorporate mile marker signage every 1/10- or 2/10-mile locations.	Low	Medium
Crashes occur during inclement weather at a higher rate than national averages. Most crash clusters occur in the eastern portion of the study corridor	Improve weather monitoring and identification. Improve response access.	High	High
within a series of horizontal and vertical curves.	Add additional DMS Boards. Incorporate large signage posted in the median and outside spaces to alert drivers of change in roadway geometries.	Medium	High
	Incorporate an adjustable speed limit corridor.	High	High
